Product Management – Coal Mining Industry

Notification IN00016 Rev1 July 2023

VSDguard, ELV-PRO and ELV-PRO RV: Latching trip contacts in AC control circuits

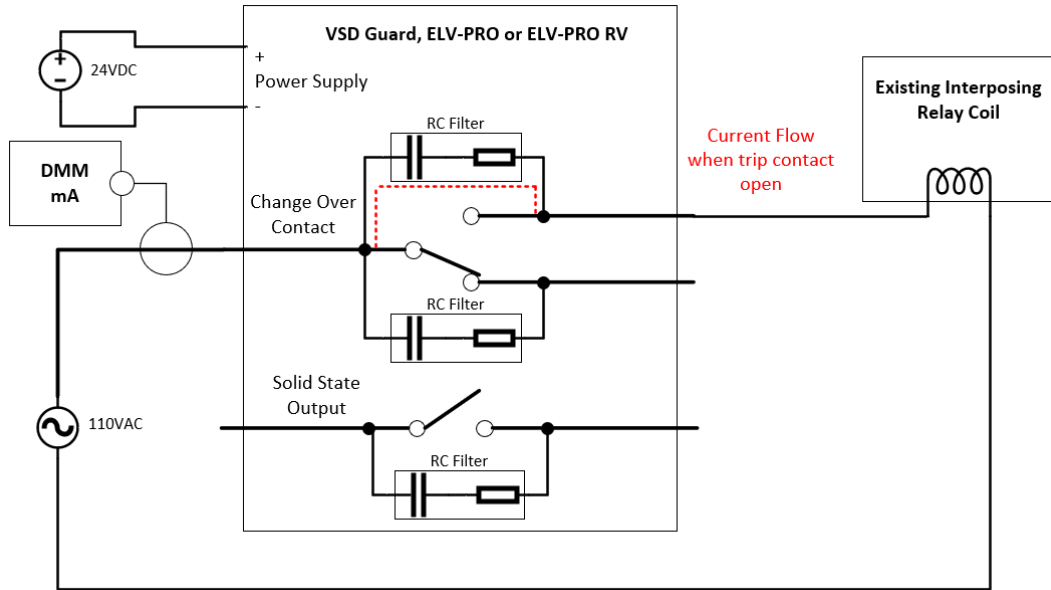
When used with a 110 VAC control supply, the internal transient suppression filter (RC combination, $22\Omega + 100\text{nF}$) across the trip contact terminals can allow up to 4.5mA of current to be sustained after the trip contacts open. This current is sufficient for OEM interposing relays with low VA ratings to hold in.

The possibility of latching is dependent on the relay coil impedance and relay's magnetic circuit, and so no specific holding current can be nominated for all installations.

Figure 1: Open Contact Filter Current Path at 110 VAC.

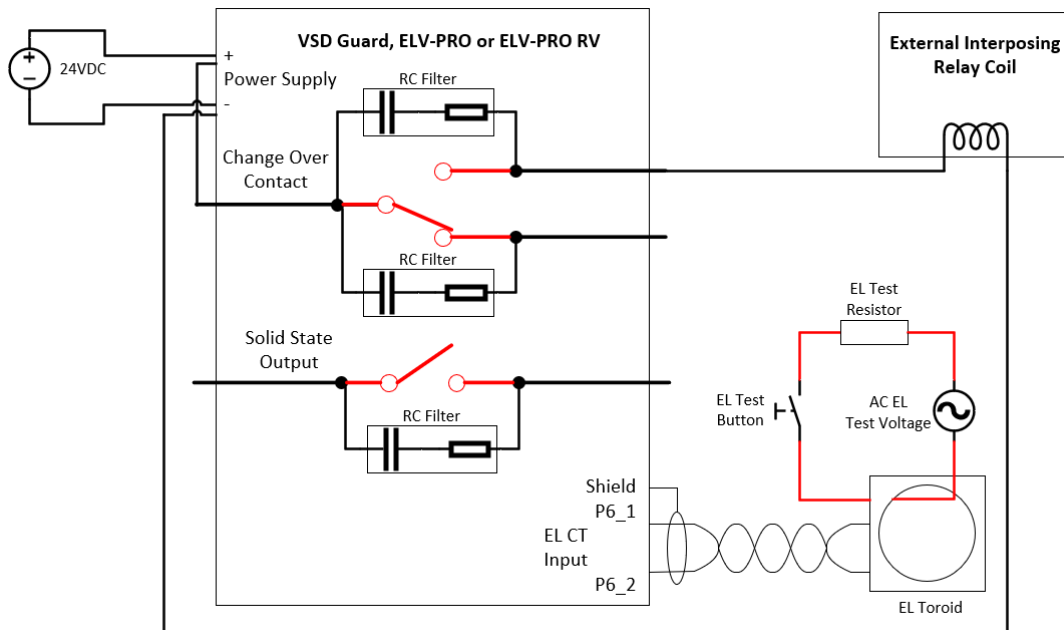
Figure 2: Use of the EL test function to assess vulnerability of the installation.

1. The vulnerability of an individual installation can be assessed via the routine Earth Leakage (EL) test function. See Figure 2. Repeated operation of the EL test will verify that the relay contacts open as intended, or whether they have a vulnerability to stay closed. Multiple operations are recommended to give a statistical reliability.

Note that during testing, the physical opening of the interposing circuit should be verified: PLC indication feedback alone does not provide adequate test coverage.

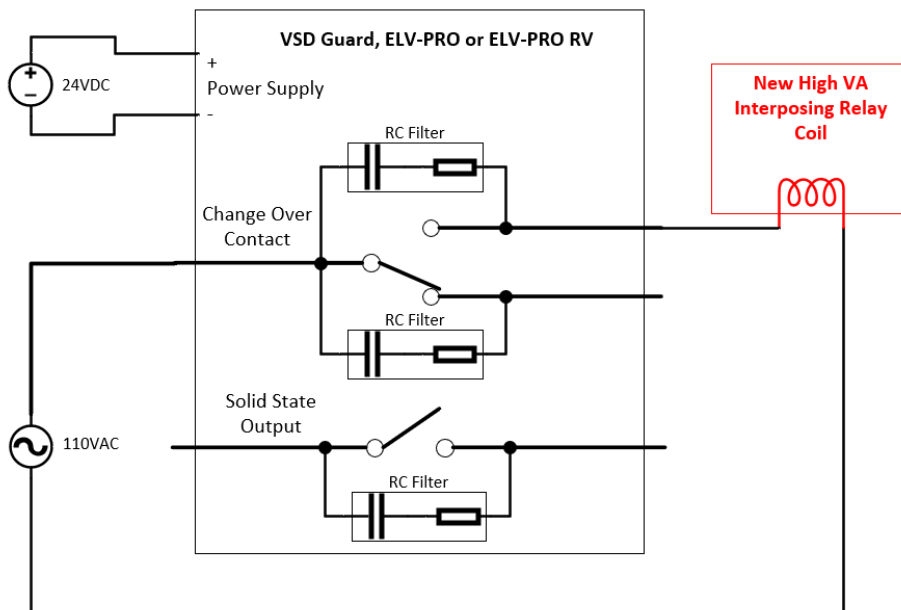
Figure 3: Use of higher VA rated relay coil circumvent vulnerability.

1. Change out the low VA rated relay coil for a higher VA rated relay coil such as those listed in the first **two rows** of Table 1. See Figure 3.
2. Change out the 110 VAC control supply for a DC control supply such as 24 VDC. See Figure 4. The DC current will be blocked by the capacitor in the transient suppression filter regardless of which relay is used.
3. Introduce a new DC interposing relay so isolate the existing AC circuit from the relay contacts. See Figure 5. Note however that this approach will increase tripping times due to the sequential relay logic. The increased tripping time increases the touch potential hazard due to extended exposure times.
4. Return the affected Ampcontrol product to Ampcontrol for removal of the Transient Suppression filter components. Note that this will become a standard repair procedure into the future.

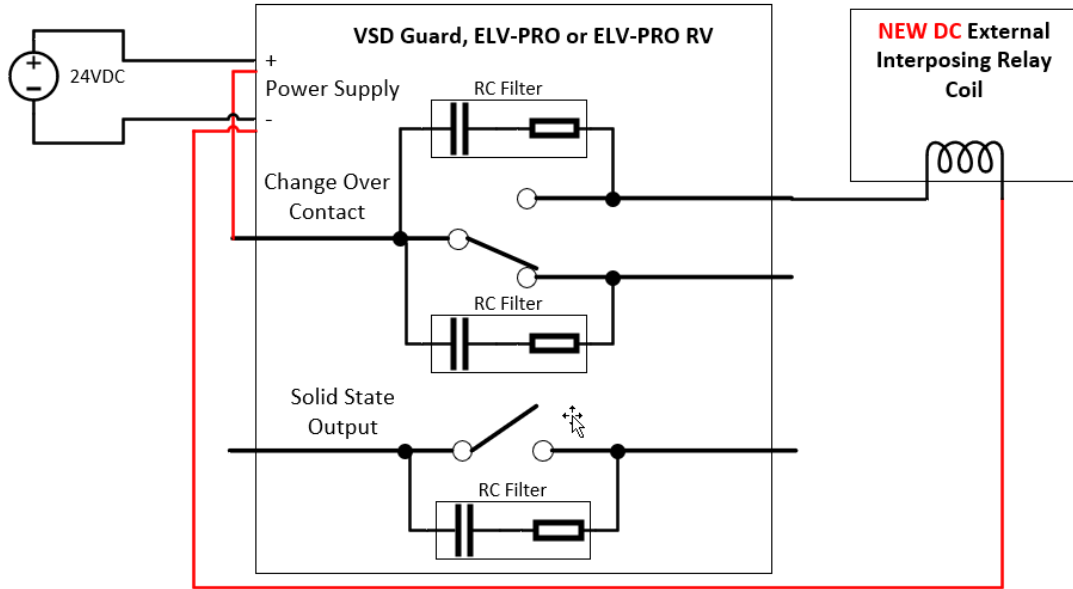
Figure 4: Use of DC control supply to circumvent vulnerability.

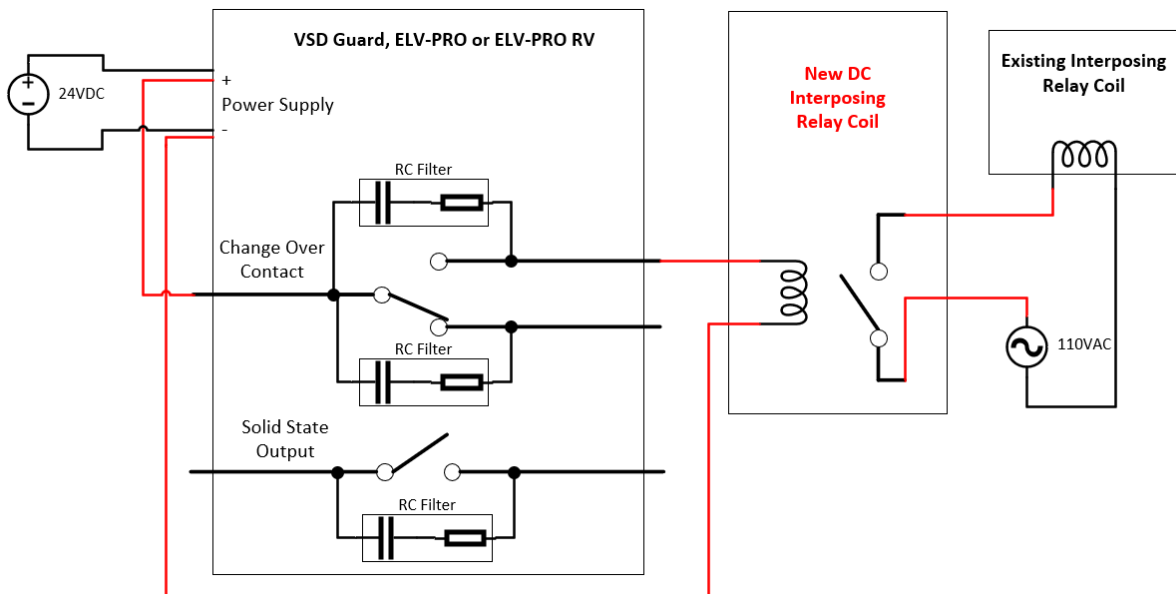
Figure 5: Use of new DC interposing relay to circumvent vulnerability. Note extended trip time.
