Product Management – Coal Mining Industry

Notification IN00016 Rev1 July 2023

VSDguard, ELV-PRO and ELV-PRO RV: Latching trip contacts in AC control circuits

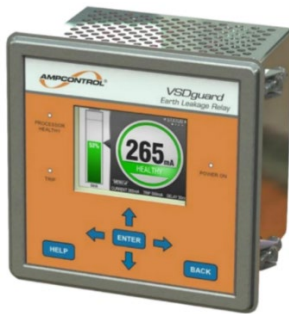
It has been identified that - in a limited set of circumstances - an internal filter used on the trip contacts of Ampcontrol's VSDguard and ELV-PRO relays can allow a current to persist when the trip relay contacts open, causing latching of the interposing relay (i.e. failure to open).

When used with a 110 VAC control supply, the internal transient suppression filter (RC combination, $22\Omega + 100\text{nF}$) across the trip contact terminals can allow up to 4.5mA of current to be sustained after the trip contacts open. This current is sufficient for OEM interposing relays with low VA ratings to hold in.

The possibility of latching is dependent on the relay coil impedance and relay's magnetic circuit, and so no specific holding current can be nominated for all installations.

It is recommended that all installations involving the affected products be reviewed to assess the possibility of the fault scenario described above occurring in practice.

1. The vulnerability of an individual installation can be assessed via the routine Earth Leakage (EL) test function. See Figure 2. Repeated operation of the EL test will verify that the relay contacts open as intended, or whether they have a vulnerability to stay closed. Multiple operations are recommended to give a statistical reliability.
